# Manhole Inspection Summary

Manhole # S61G\_\_009MH

Insp Date: **3/28/08 10:22 AM**

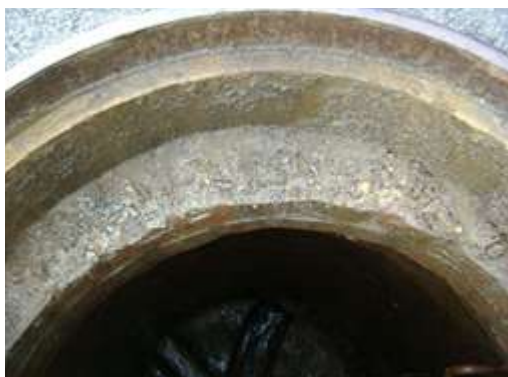
Defect 3

Offset: **4** (in.)

Frame offset defect

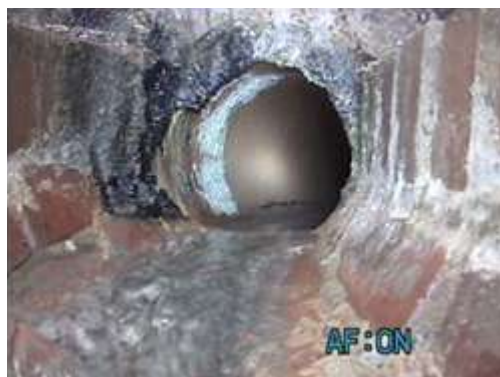
Defect 3

Infiltration: ☐ None ☐ Joint ☐ Cracks ☐ Mortar ☐ Roots ☒ **Wall**

Infiltration on barrel wall and attached grease in incoming pipe

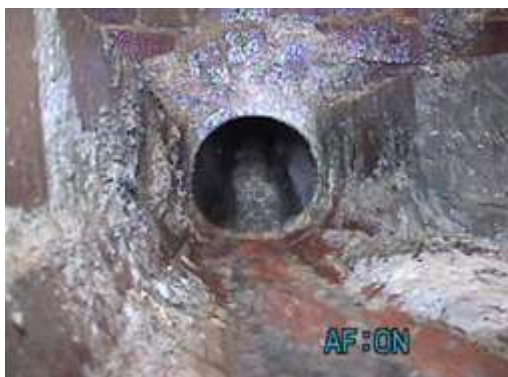
Defect 1

infiltration on barrel wall above 120

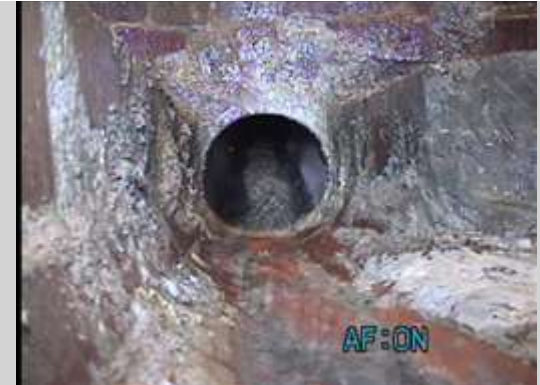
12 O'Clock Outflow

Pipe Height: **8.4** (in.) Rod and Bar (Angled)  
Pipe Material: **Clay** ☐ Pipe Lined  
Invert Depth: **10.25** (ft.) Flow Characteristics: **Fast**  
Deposits: ☐ None ☐ Mud ☐ Sludge ☐ Debris ☒ **Grease**  
Silt Depth: **0.25** (in.) Deposits Extent: **Light**  
Infiltration: **None** Pipe Seal Cond: **Sound**

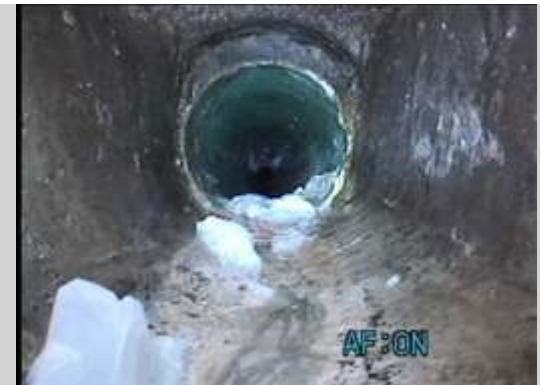
3 O'Clock Inflow

Pipe Height: **8.4** (in.) Rod and Bar (Angled)  
Pipe Material: **PVC** ☐ Pipe Lined  
Invert Depth: **9.67** (ft.) Flow Characteristics: **Fast**  
Deposits: ☐ None ☐ Mud ☐ Sludge ☒ **Debris** ☐ **Grease**  
Silt Depth: **1.5** (in.) Deposits Extent: **Light**  
Infiltration: **None** Pipe Seal Cond: **Sound**

☒ Possible Illicit Connection

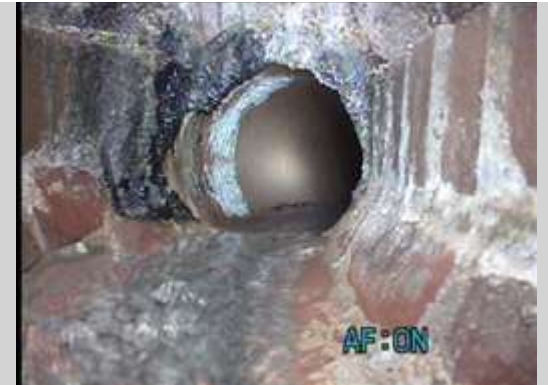
6 O'Clock Inflow

Deposits: ☐ None ☐ Mud ☐ Sludge ☐ Debris ☒ **Grease**

Silt Depth: **0.25** (in.) Deposits Extent: **Light**
